Refractory Metal Liner Processing for M242 Medium Caliber Barrels

ARL-TR-6301

January 2013

William S. de Rosset and David Gray
Weapons and Materials Research Directorate, ARL

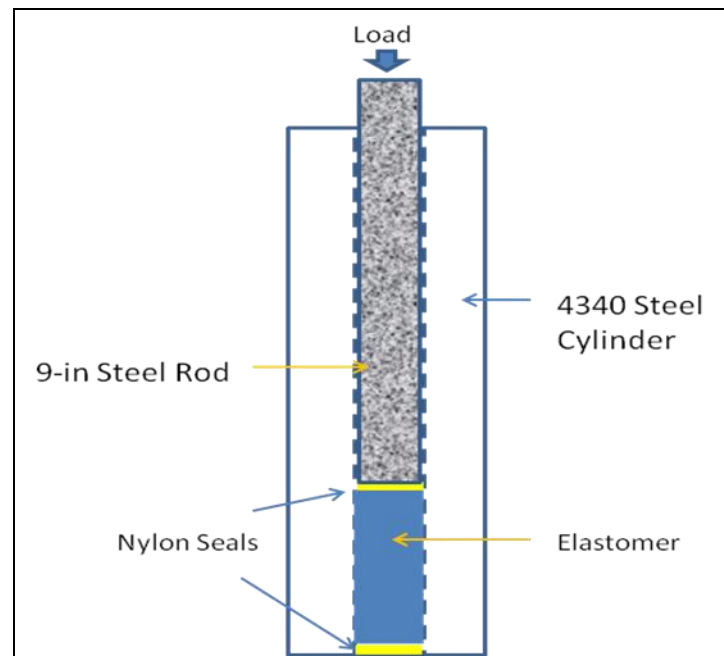
The first cylinder was pressurized in three sections. In order to do this a 9-in steel load rod had to be used to transfer the load from the load frame to the first 4-in elastomer section and seals. A schematic of the test arrangement for the first section is shown in figure 1.

Figure 1. Experimental setup of the first pressurization.

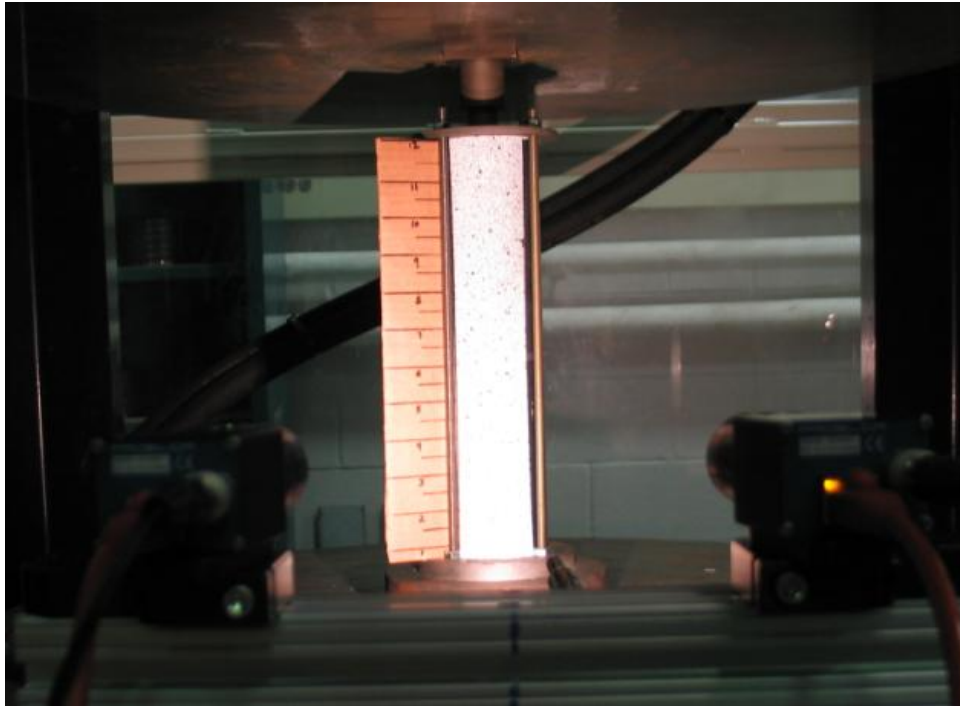
DIC was used to measure several components of strain over a large area of the steel cylinder's surface. In this measurement technique a speckled pattern is applied to the surface of the steel cylinder; two cameras are used to produce stereo-optic image of the cylinder surface. As the cylinder expands due to the pressurization, the speckle pattern is distorted, and the image can be analyzed by computer software to measure the components of strain. A picture of the experimental setup is shown in figure 2. Details of the test fixture used in the GLEEM process can be found in (7).

Figure 2. Experimental setup of DIC strain measurement using the GLEEM testing fixture as detailed in (7).

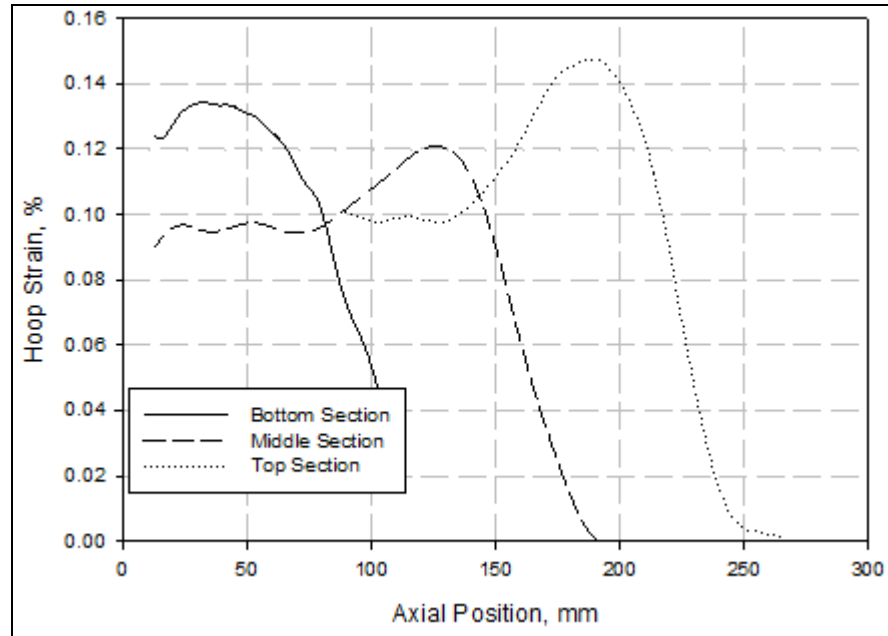
A compression load of 120,000 lb was used for the first cylinder which produced an internal pressure of 152.7 ksi, assuming no frictional effects. This was below the yield point of the steel, assumed to be 160 ksi. Hoop strain measurements are shown in figure 3, taken at the time the maximum load was applied to the elastomer. The origin of the plot is the bottom of the cylinder.

Figure 3. Measured hoop strain as a function of axial position for first 12-in steel cylinder.

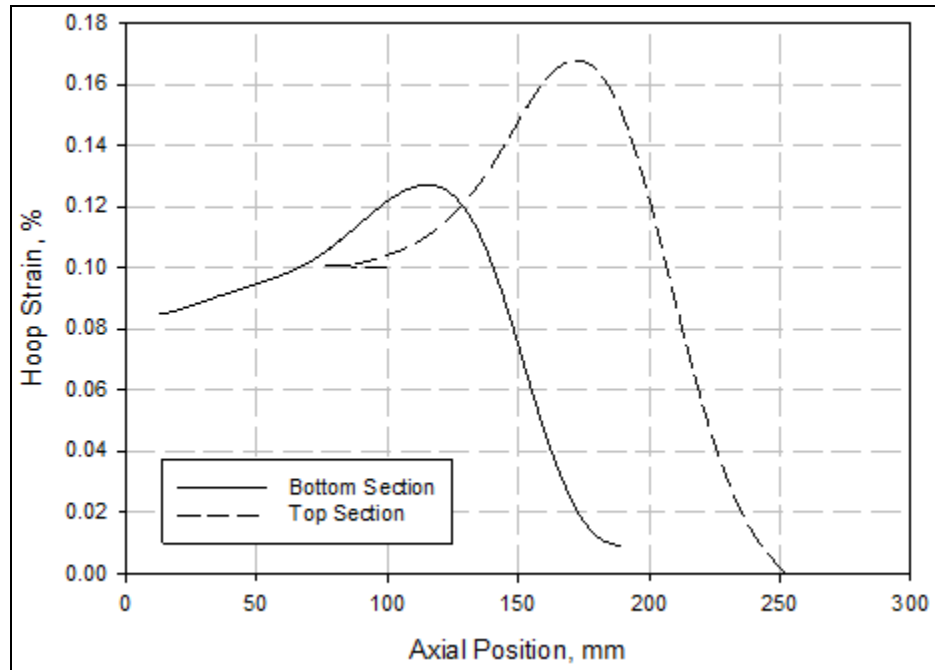
A second steel cylinder was pressurized using an 8-in elastomer section and a 4-in elastomer section. In choosing the 8-in length, a compromise was made. On one hand, the length had to be long enough to reduce the number of steps that would be needed for the truncated M242 tube. On the other hand, the length had to be short enough to reduce the effects of friction down the length of the elastomer section. A compression load of 160,000 lb was used for the second tube in order to obtain some plastic deformation of the steel cylinder; this load gave an internal pressure of approximately 204 ksi. DIC measurements were also used to obtain the strain components on the outer surface of the steel cylinder. Results are shown in figure 4. After the GLEEM process had been applied to the cylinder, measurements of the inner diameter of the steel cylinder were made. There was no noticeable enlargement of the cylinder.

Figure 4. Hoop strain measurements as a function of axial position for the second steel cylinder (8-in and 4-in plugs).

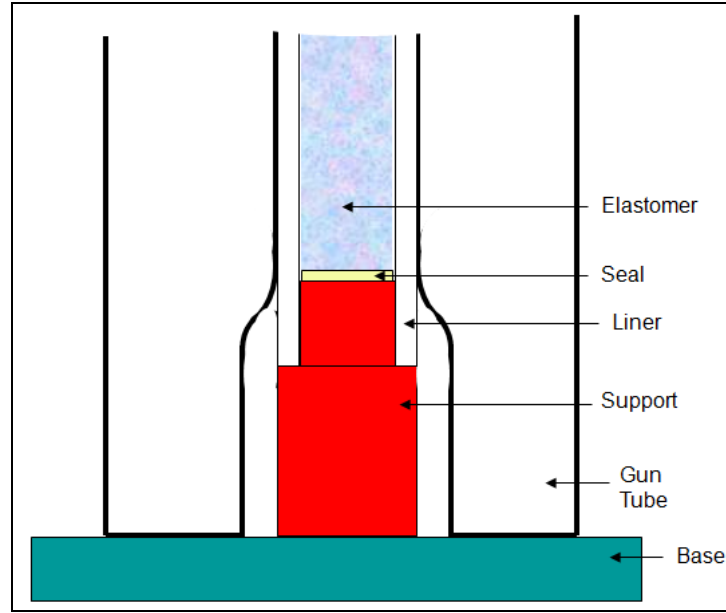
For the last pass, the gun barrel was inverted, all the elastomer removed, and an 11-in Teflon bar inserted into the breach end of the liner. A steel rod supported the elastomer, as shown in figure 7. A 26.5-in load rod was used to apply a load of 130 kip for 30 min to the elastomer. Note that since the gun barrel was inverted, the load rod did not pass through the gun chamber. Consequently, the unsupported length was much lower than those for the other passes. This completed the processing of the first gun barrel.

Figure 7. Details of support arrangement (not to scale).

The first four passes used the same support shown in figure 7.

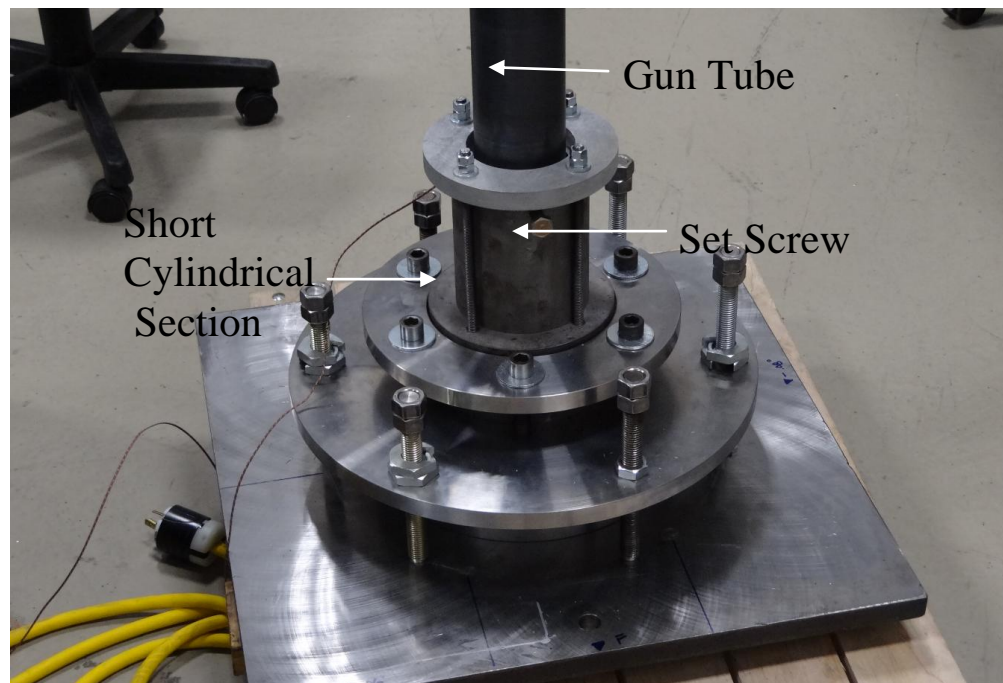
An incorrect length load rod was used on the first pass for the second barrel, and before a load of 136 kip was obtained, the load rod bent. The procedure was halted and re-examined. Since the unsupported length was still well below that needed to buckle the rod, it was conjectured that a slight misalignment of the gun tube was causing premature failure of the load rod. It was decided that a better way to align the gun tube in the load frame was needed. A new base fixture, shown in figure 9, was designed to allow small adjustments in the angle the gun tube made with the load frame (11). A Pro 3600 digital protractor was used to assure that the gun tube was vertical to ± 0.1 degree. In addition, two dial indicators were positioned 90° to each other to indicate motion of the gun tube during processing. With these improvements, the first four passes were successfully completed. The load was ramped to 136 kip at a rate of 10 kip/min and held for 30 min. Load release occurred at a rate of 15 kip/min. The gun tube was then inverted and a fifth pass attempted. For this pass, straps were applied to the gun tube to prevent a large motion and possible damage to the load frame. Approximately 15 min into the hold portion of the pass, the dial indicators began to indicate rapid gun tube deflection, and the test was halted. It was later determined that the bottom nylon seal had been extruded out of the gun tube and was the possible cause of the gun tube starting to tip. The load rod was slightly bent at the end with the tapped hole. The indicators successfully detected motion before any gross movement of the gun tube occurred.

Figure 9. Gimbaled base alignment test fixture for M242 gun tube.

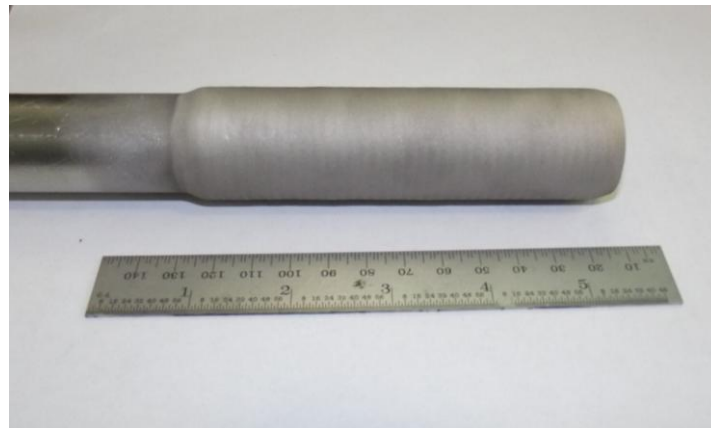
During the test firing of the first barrel, the liner was observed to extend in the tube (see section 6.1). Based on these results, the Stellite 25 liner was modified in an attempt to keep it in place during firing tests of the third barrel. The rear end of the Stellite 25 tube was cold sprayed with pure nickel, then machined so that it could fit precisely inside a matching surface of the gun tube. The small shoulder was expected to provide enough resistance to keep the liner in place during the firing trials. Figure 10 shows the end of the Stellite 25 tube after it has been cold sprayed.

Figure 10. Picture of Stellite 25 tube with nickel cold-sprayed at one end (not machined).

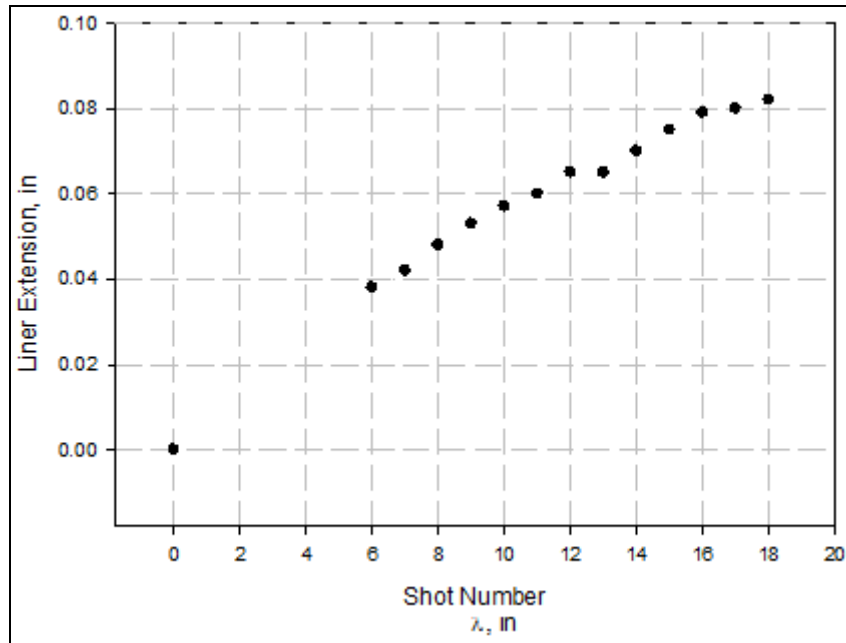
Firing of the first barrel continued in test facility 162A, building 390 at ARL. After the first shot, the liner extension out of the barrel was measured at a particular spot. Measurements were taken at this position for the remainder of the tests so that a consistent set of values was obtained. The results are shown in figure 11. The measurement taken after the eighteenth shot was 0.082 in. While the rate of liner extension out of the tube appeared to be decreasing with the shot number, it was still too large to be acceptable. A least squares fit to the data indicated that the liner moved 4.3×10^{-3} in (1.6×10^{-4} mm) per shot.

Figure 11. Liner extension versus shot number for barrel number 1.

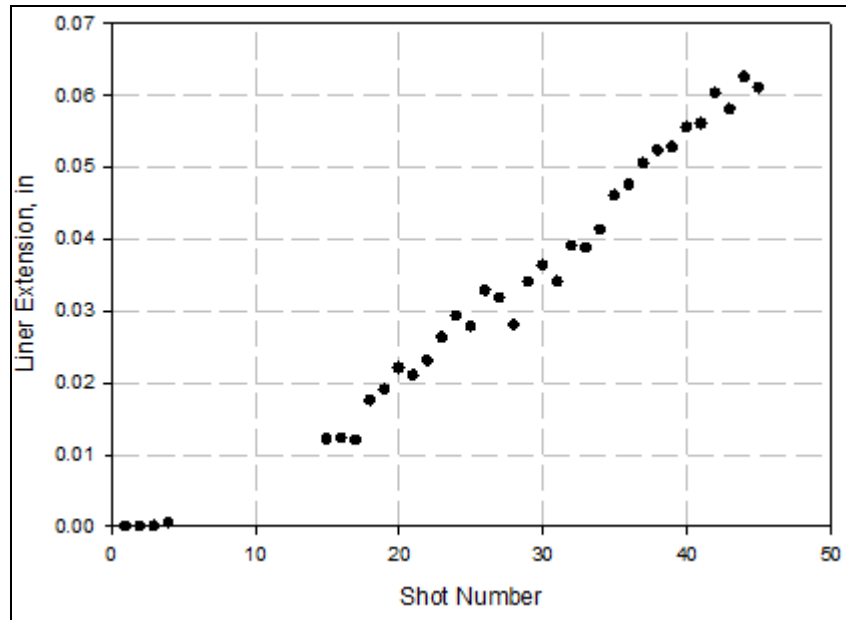
After 16 more firings, the firing pin in the breech mechanism broke, and tests were suspended until a new firing pin could be obtained. When testing resumed, the remaining 14 shots were fired. Figure 12 shows the measured liner extension as a function of shot number. A least squares fit to the linear portion of the curve indicated that the liner moved 1.7×10^{-3} in (6.7×10^{-5} mm) per shot. Figure 13 is a photograph of the muzzle end of the gun tube showing the liner extension after completion of all the firing tests.

Figure 12. Liner extension versus shot number for barrel number 3.

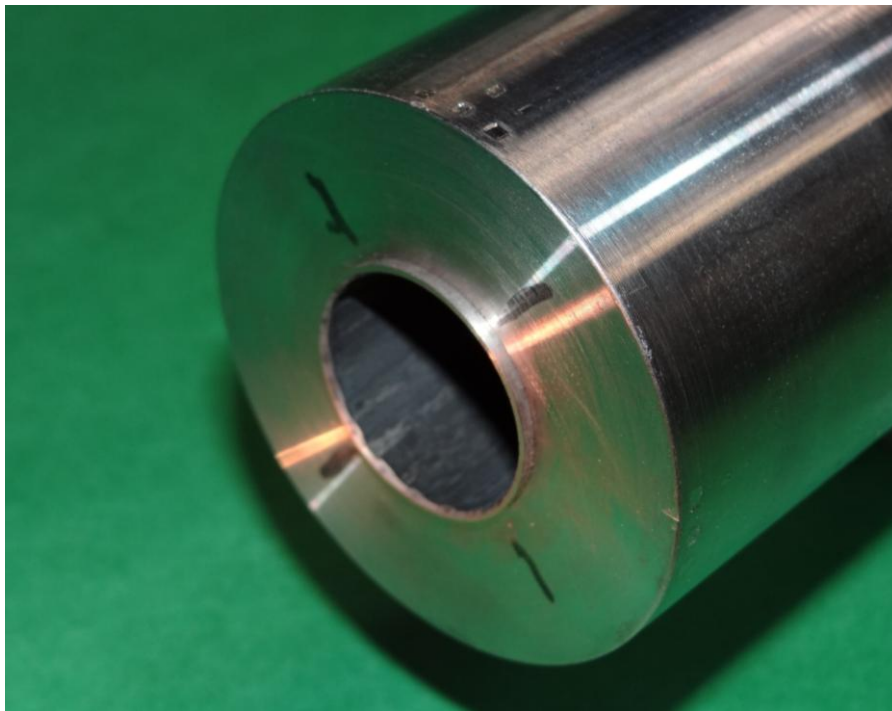
Figure 13. Muzzle end of the third barrel showing liner extension.

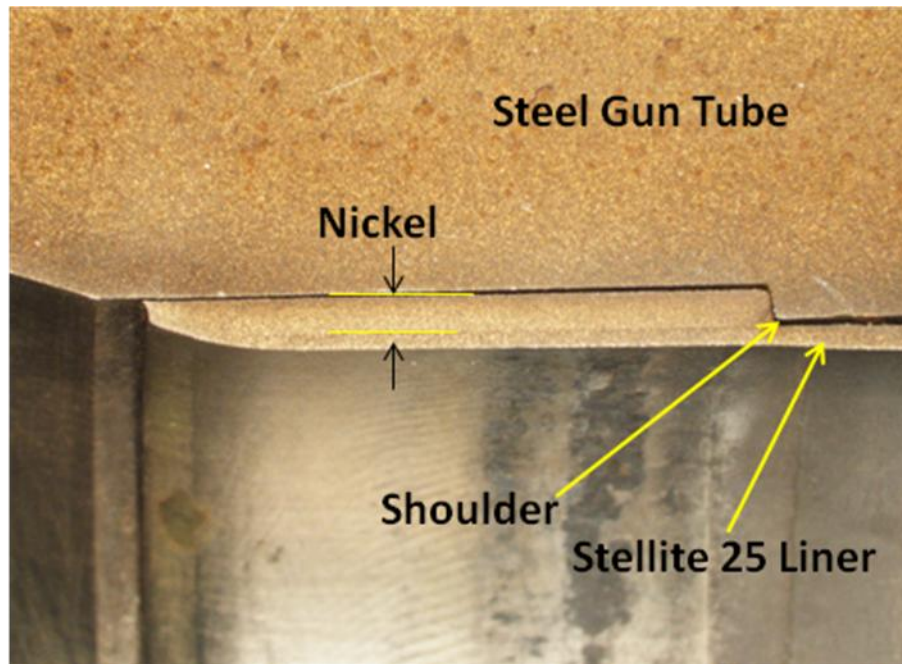
The breech end of the third barrel was sectioned in a manner similar to that of the first barrel. As before, the liner fell out of the tube in the chamber area when the tube was sectioned parallel to its axis. Figure 15 shows a cross section of the gun tube and liner. The liner has been placed back in the gun tube where it was originally positioned. It is clear that the shoulder in the steel tube and the cold sprayed nickel prevented any motion of the liner. The nickel can be seen as a thin strip bonded to the Stellite 25 liner.

Figure 15. Cross section of liner and gun tube near the breech end of the third barrel.

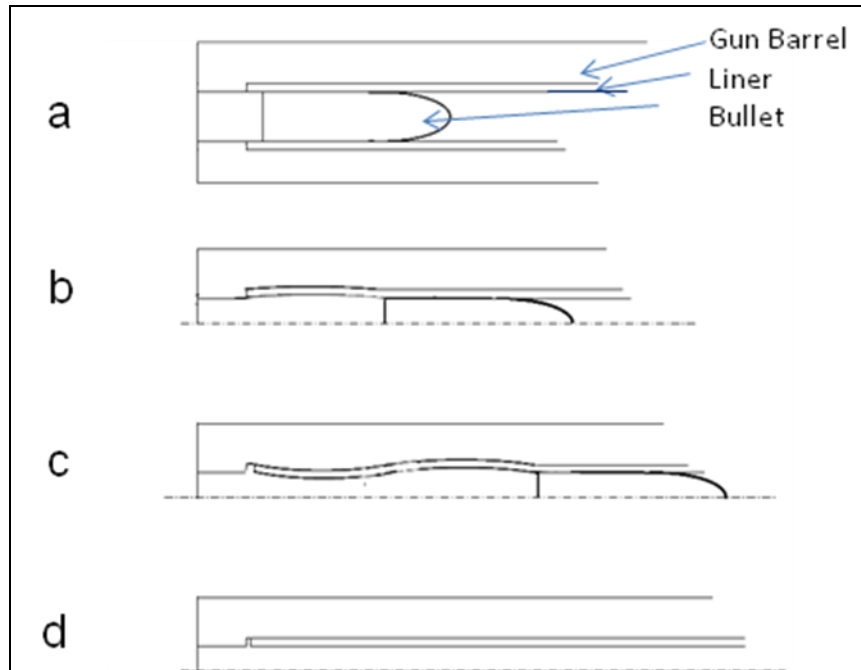
It was not expected that the liner would extend from the tube, based on the bond strength achieved in laboratory tests. This was assuming that the liner acted as a rigid body. The observations that the liner did extend motivated a re-examination of this assumption. It is quite possible that the liner extension was due to the dynamic nature of the interior ballistic process. Figure 16 portrays how the liner movement might occur. Figure 16a shows the bullet in the chamber before propellant ignition. After ignition, the bullet begins to move down the barrel (figure 16b). Immediately behind the bullet, the gun tube and liner expand slightly due to the pressurized gasses. This may stretch the liner, and it could begin to pull away from where it was seated. The pressure is reduced in figure 16c and the liner and gun tube rebound, moving the liner still further away from its original seated position. Finally, in figure 16d, the pressure in the tube is gone. However, the liner might never return to its original position. In this way, the entire liner does not move at once, so that it does not move as a rigid body. Its motion is not unlike that of a wrinkle moving a rug a small amount as it traverses the length of the rug. In this way, liner extension can be a result of both liner stretching and liner movement.

Figure 16. Possible liner motion.

The fact that the total liner extension observed for the first barrel was more than the measured liner displacement at the breech of the gun (0.082 in vs. 0.027 in) suggests that the extension is due to both liner displacement and liner stretching. This hypothesis was supported by the test results for the third barrel. Here, the rear of the liner was pinned in place by the cold-sprayed nickel shoulder. However, a liner extension of 0.062 in after 45 shots was observed. This extension must be due only to liner stretching. On a per-shot basis, the stretching of the liner in the third barrel is much less than that observed for the first barrel (0.0014 in/shot versus 0.0032 in/shot).
